# Accu-Spec Inspection Services, PC

## Home Inspection Report

**1984 River Vista Circle**

Inspected on Tue, Nov 28 2023 at 1:00PM

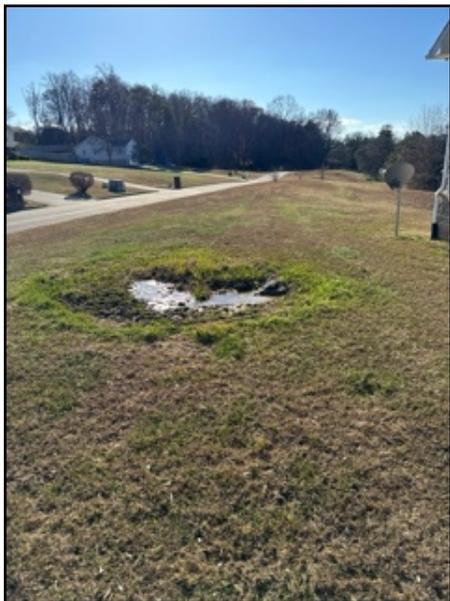
Figure 1-1

There is a wet spot in the right side yard that should be further investigated. The utility water service provider should be contacted. If the utility company has no pipe in the vicinity, a French drain may need to be installed in order to redirect the water to a different part of the property.

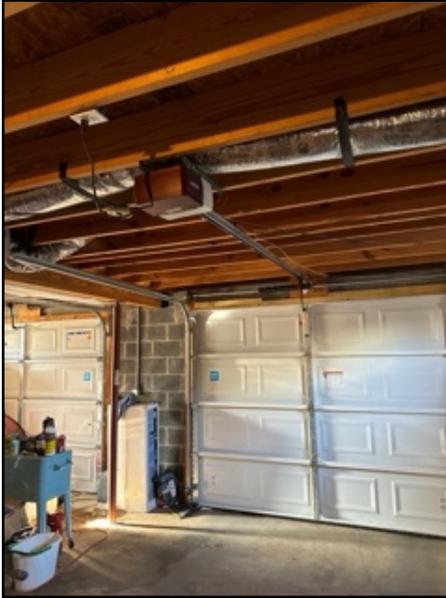
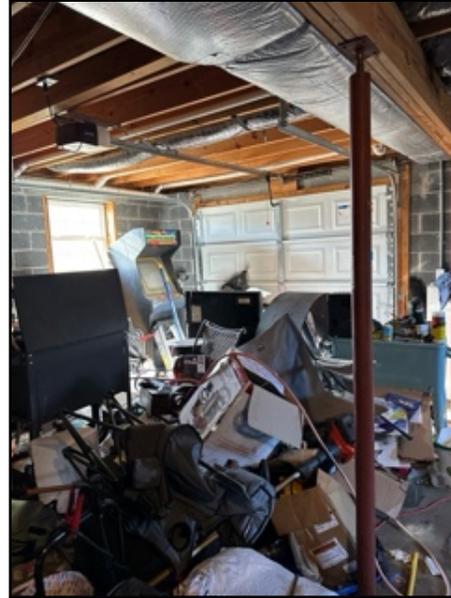
**i** Comment 2:  
The garage door opener switches were not available to operate the doors.  
Therefore, the garage door openers could not be tested.

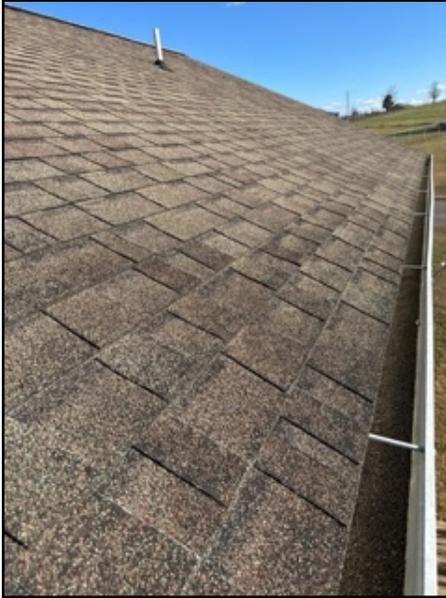
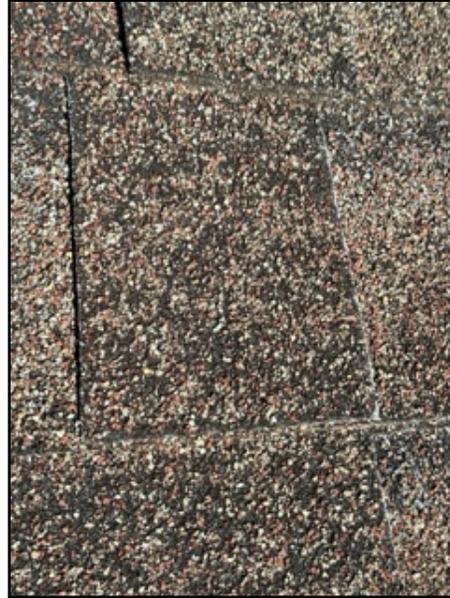
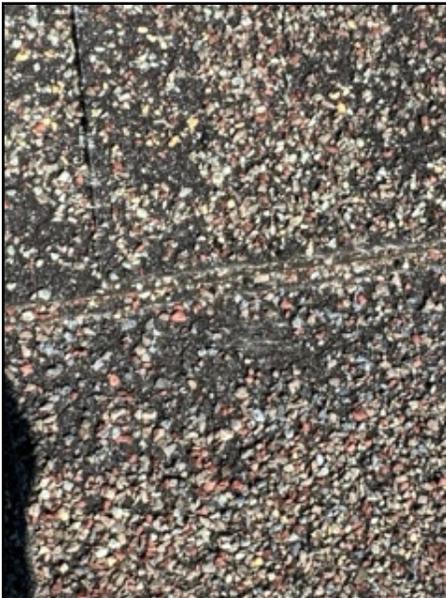
The roof shingles may have some service life left in the short run, but are nearing their normal life expectancy.

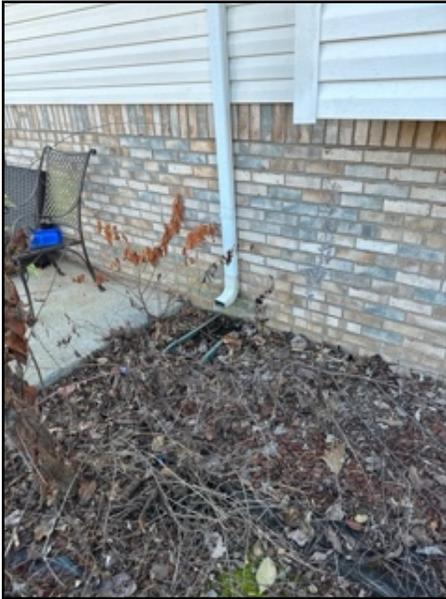
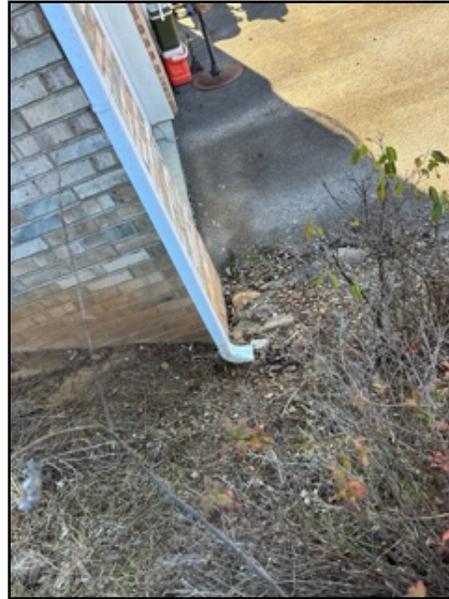
1) All gutter downspouts should be piped to discharge away from the house a minimum of 10 feet from the foundation and in a way that permanently allows water to drain away from the foundation at discharge. Water spillage adjacent to the foundation can enter the under floor areas.

All gutter downspouts should be piped to discharge away from the house a minimum of 10 feet from the foundation and in a way that permanently allows water to drain away from the foundation at discharge. Water spillage adjacent to the foundation can enter the under floor areas.

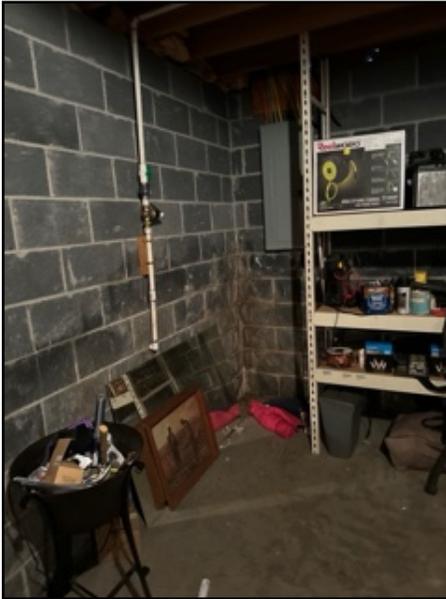
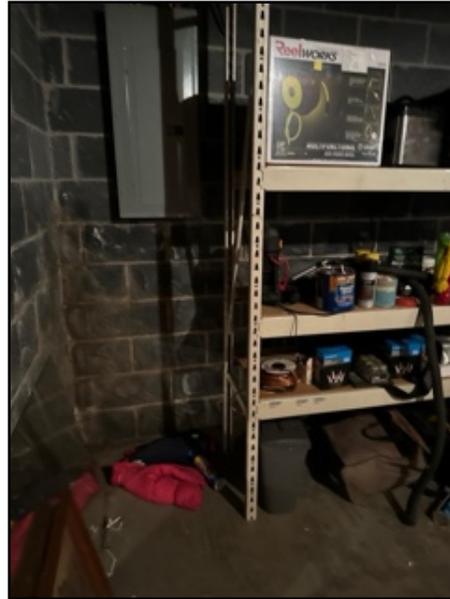
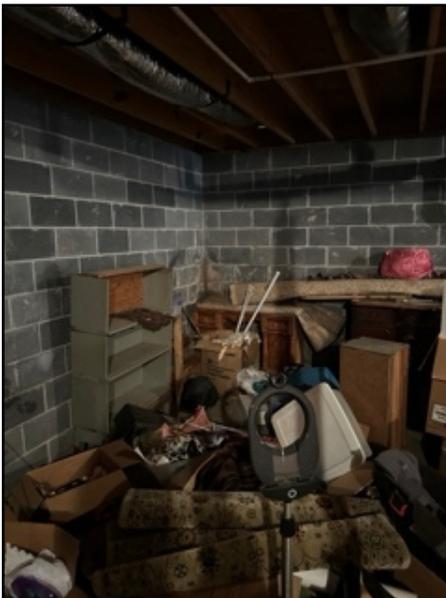
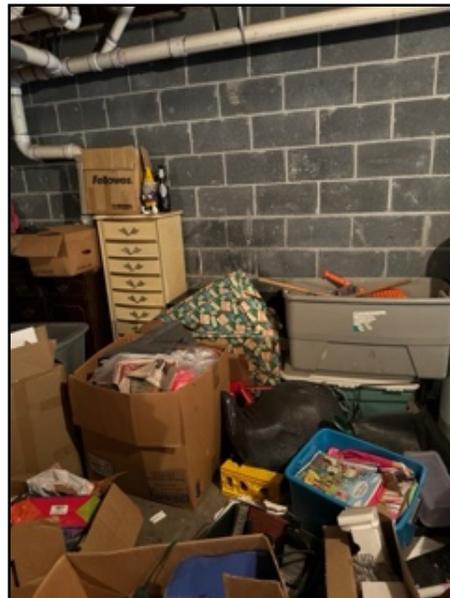
2) Current water intrusion is visible on the interior of the foundation walls of the basement. Roof and surface water should be drained away from the foundation. Grading improvements are recommended.

Current water intrusion is visible on the interior of the foundation walls of the basement. Roof and surface water should be drained away from the foundation. Grading improvements are recommended.

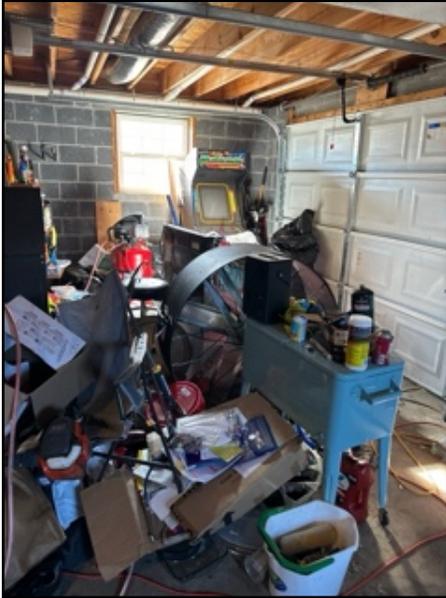
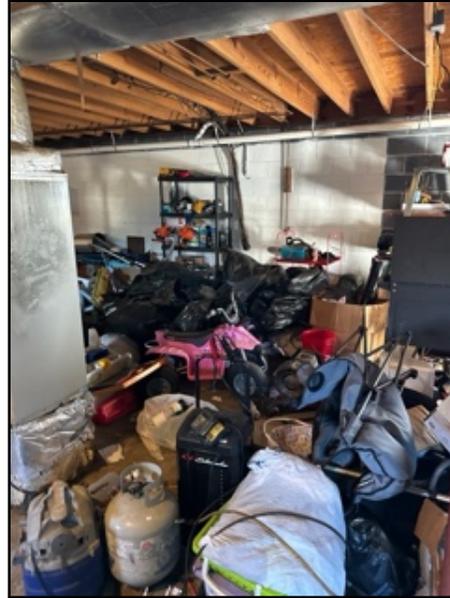
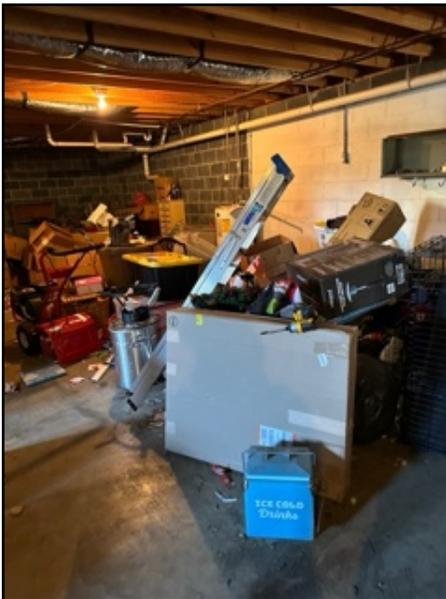
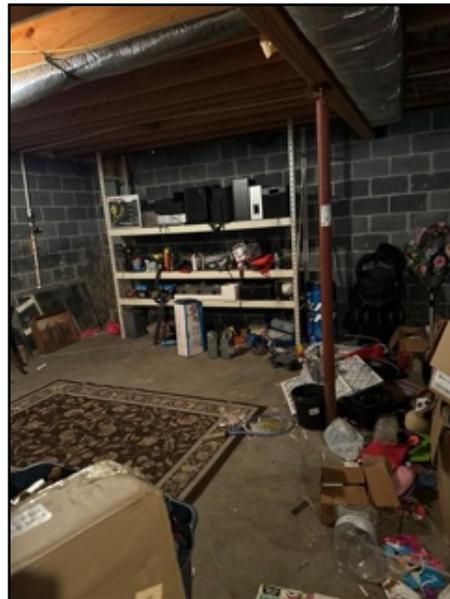
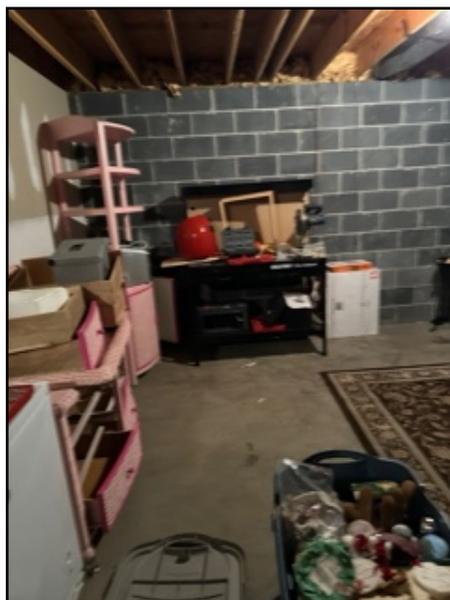
Storage in the garage and basement prevented access to the walls and floor areas.

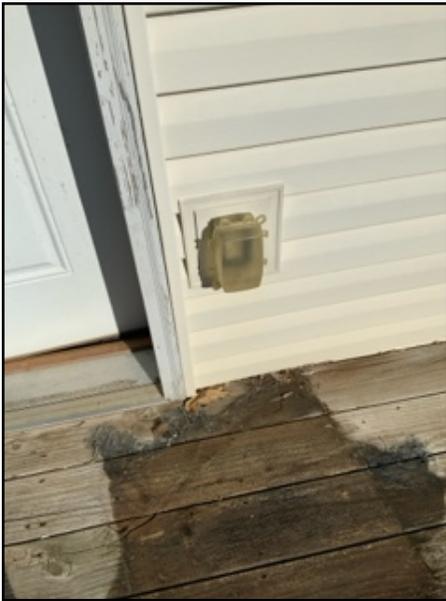
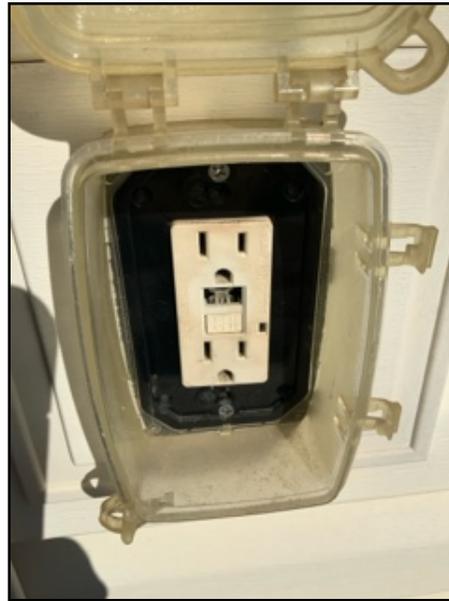
3) The damaged GFCI outlet on the rear deck should be replaced.

The damaged GFCI outlet on the rear deck should be replaced.

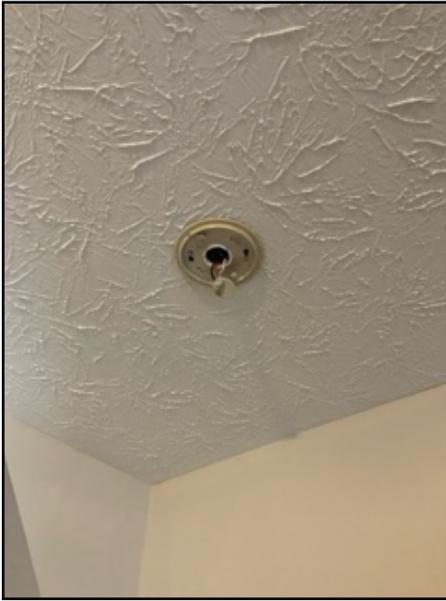
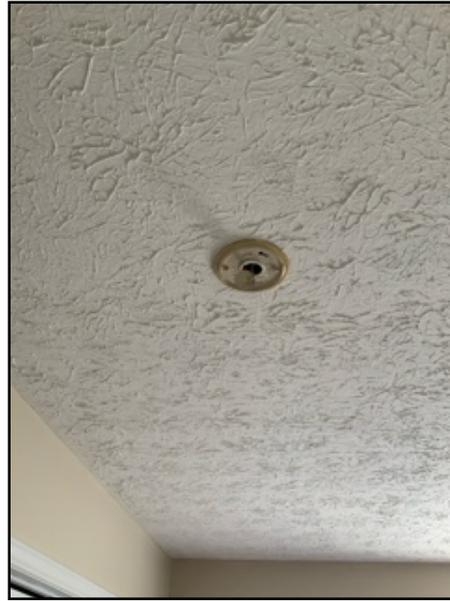
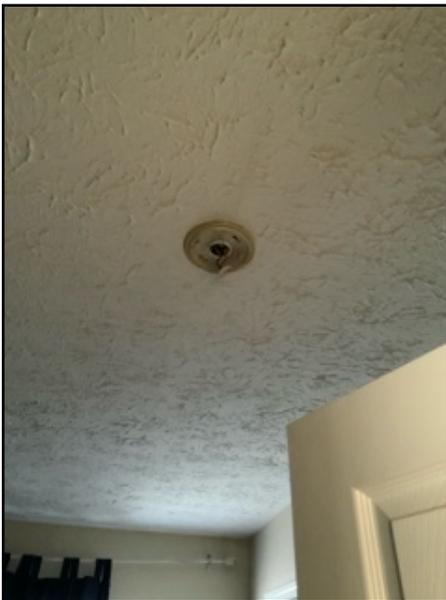
4) The smoke detectors missing throughout, should be replaced. Installation of 10 year battery units with interconnectivity are now recommended inside and outside sleeping rooms and on each level.

The smoke detectors missing throughout, should be replaced. Installation of 10 year battery units with interconnectivity are now recommended inside and outside sleeping rooms and on each level.

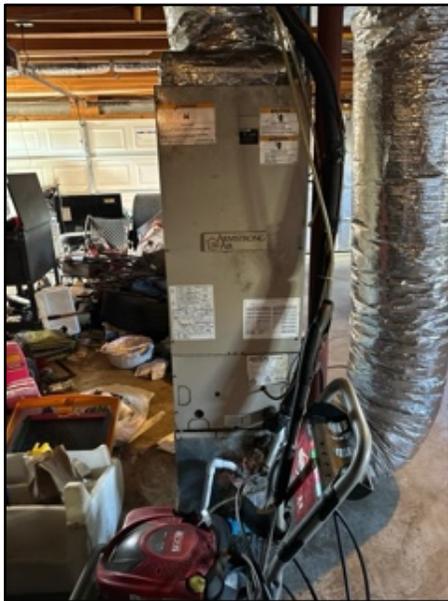
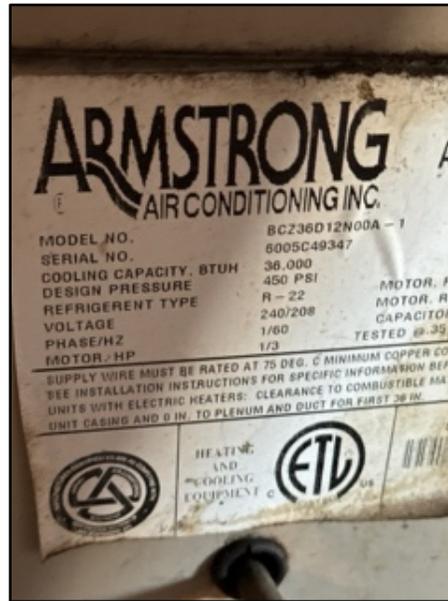
5) The heat pump is an older unit based on normal life expectancies for heat pumps.

The heat pump is an older unit based on normal life expectancies for heat pumps.

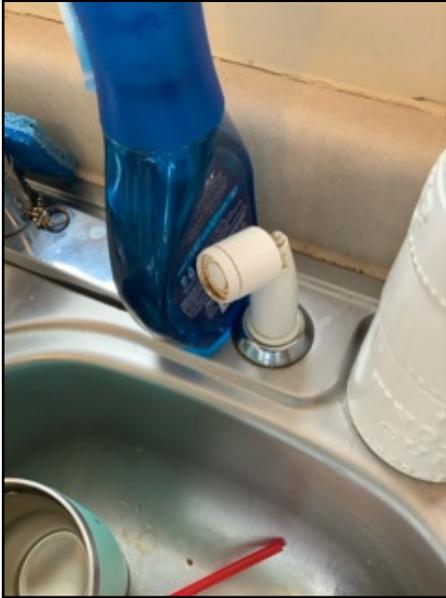
Figure 10-1

6) The vegetable sprayer is damaged and should be replaced.

The vegetable sprayer is damaged and should be replaced.

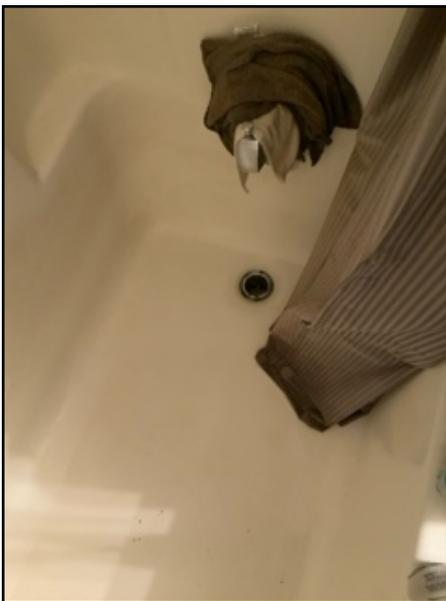
Figure 11-1

7) The master tub bath drain stopper is missing.

The master tub bath drain stopper is missing.

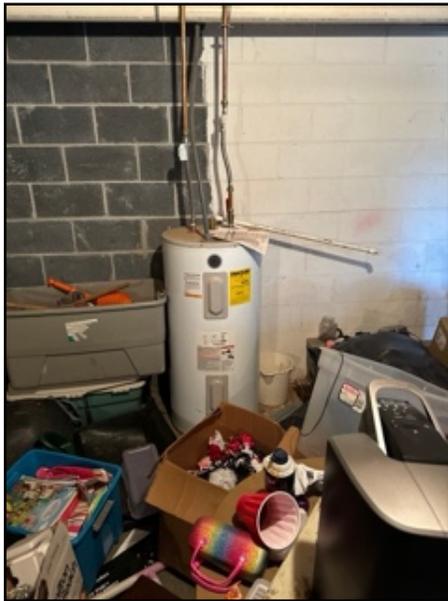
Figure 12-1

8) The temperature and pressure relief valve at the water heater is missing an extension pipe. The extension pipe should terminate to within 6-12 inches of the garage floor, or, to the outside.

The temperature and pressure relief valve at the water heater is missing an extension pipe. The extension pipe should terminate to within 6-12 inches of the garage floor, or, to the outside.

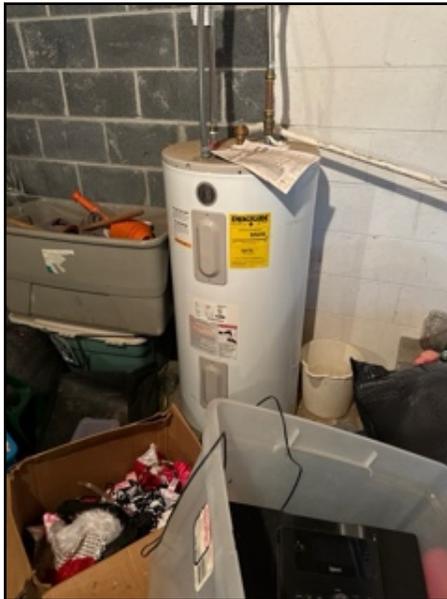
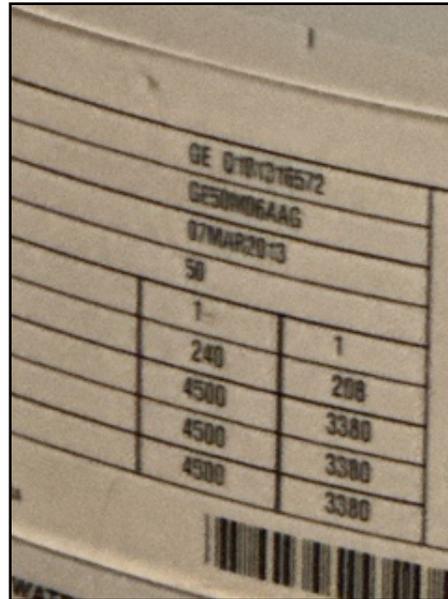
9) The water heater is an older unit based on the normal life expectancy of these units.

The water heater is an older unit based on the normal life expectancy of these units.

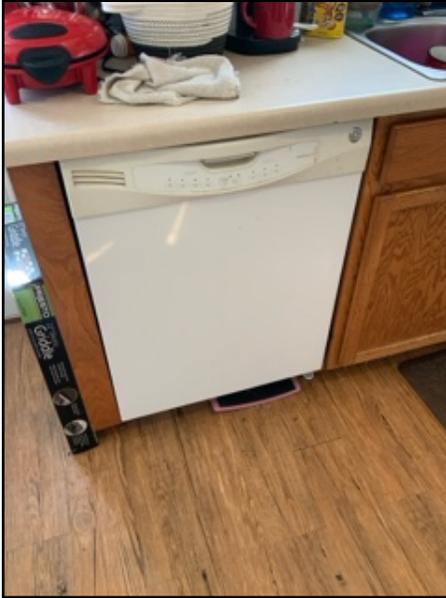
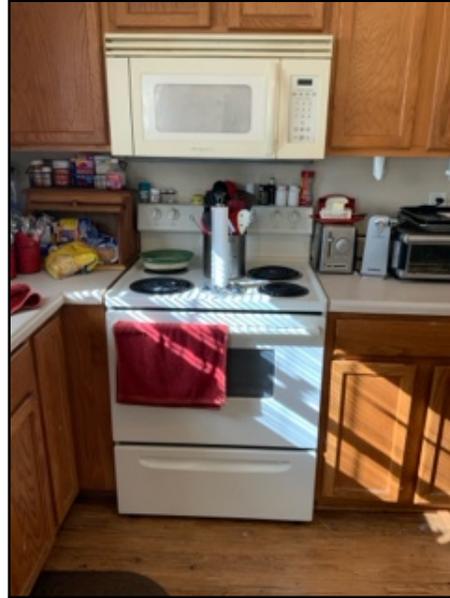
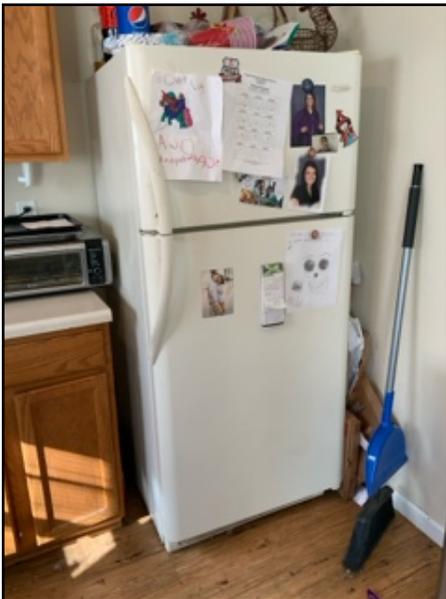
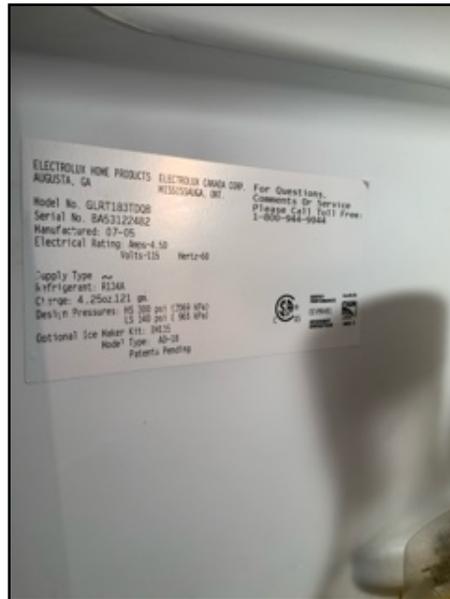
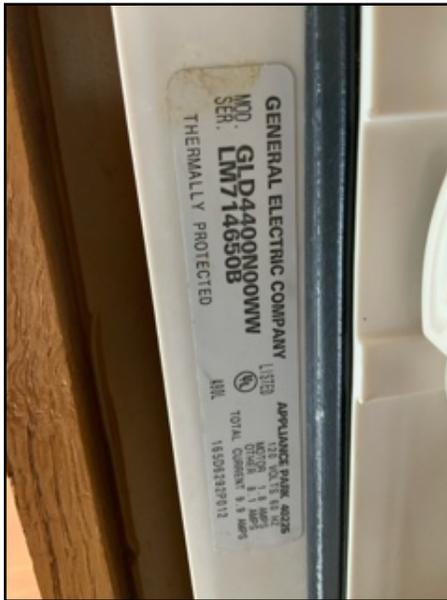
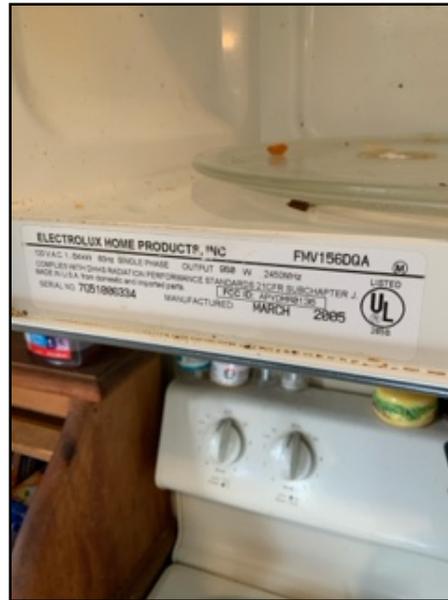
10) The microwave, dishwasher, electric range and refrigerator are older units.

**Comment 14:**  
The microwave, dishwasher, electric range and refrigerator are older units.

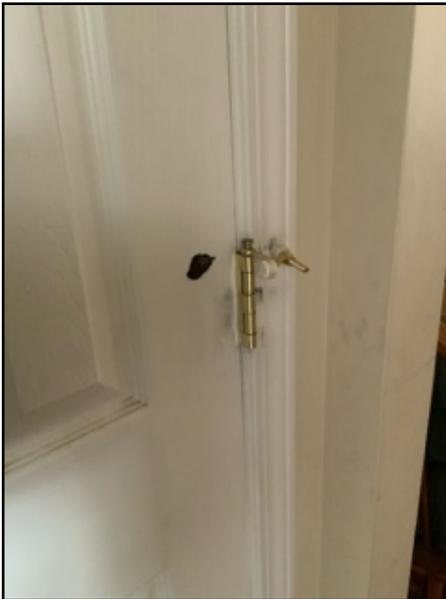
Figure 15-1

11) The linen closet door is damaged. Minor repair is needed.

The linen closet door is damaged. Minor repair is needed.

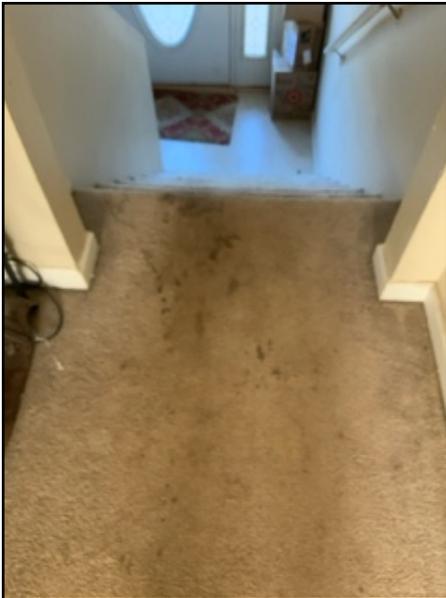
Figure 16-1

12) The carpet on the upper floor is cosmetically damaged. Cleaning or replacing the carpet is needed in the short run.

The carpet on the upper floor is cosmetically damaged. Cleaning or replacing the carpet is needed in the short run.
