Home Inspection Report

2627 Mountain Blvd

Sevierville, TN 37876

Inspected on Thu, Aug 15 2024 at 10:00AM

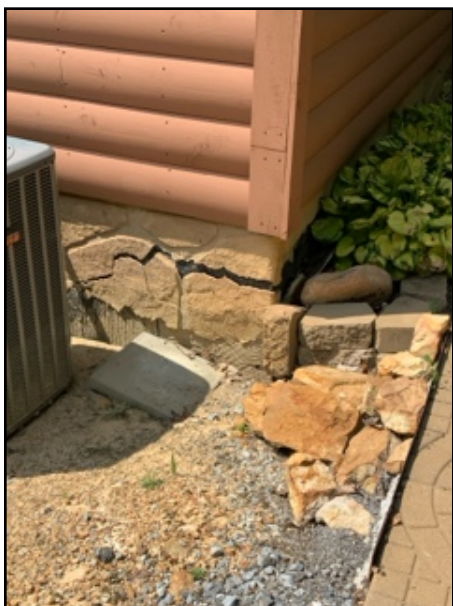
Figure 1-1

**Comment 1:**
Minor stucco repairs are needed at the rear corner of the house foundation.

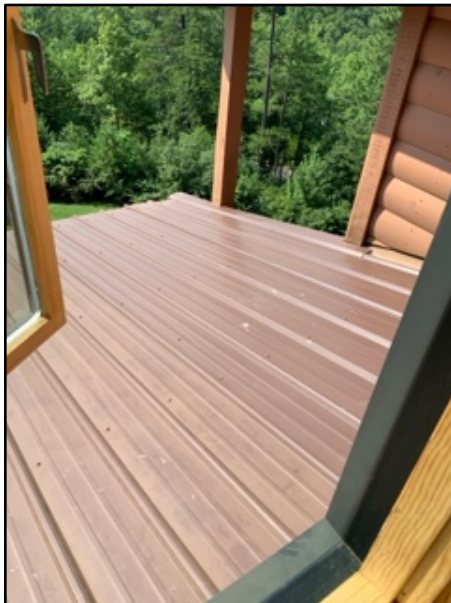
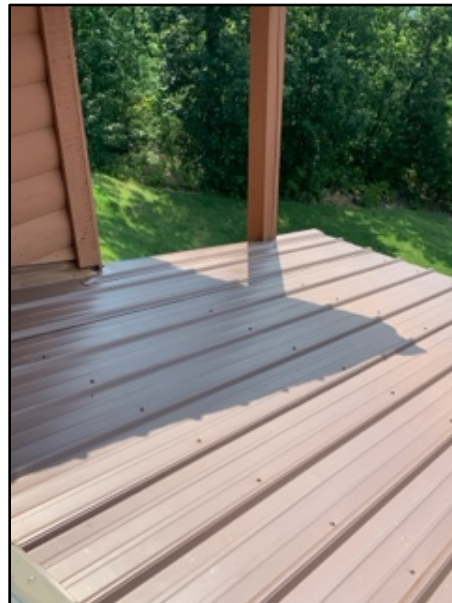
Some roof panels are installed with the panels incorrectly lapped according to the manufacturer installation instructions. This is a common condition and does not usually affect the longevity of the roof panels.

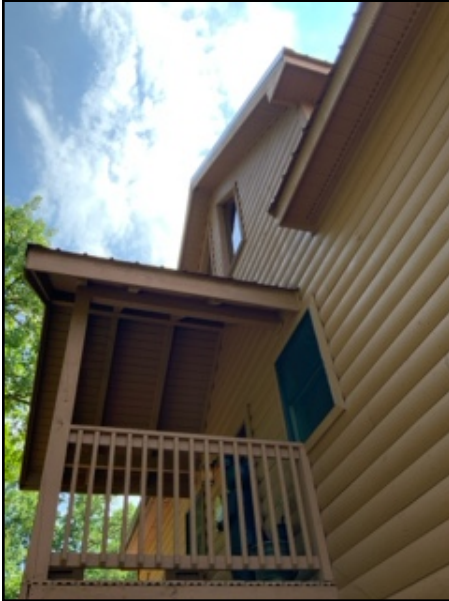
Figure 3-1

Installation of guttering on the back side of the house, complete with downspouts and extension pipes, is recommended in order to better control roof water. Spillage of roof water can result in water intrusion into the masonry and basement.

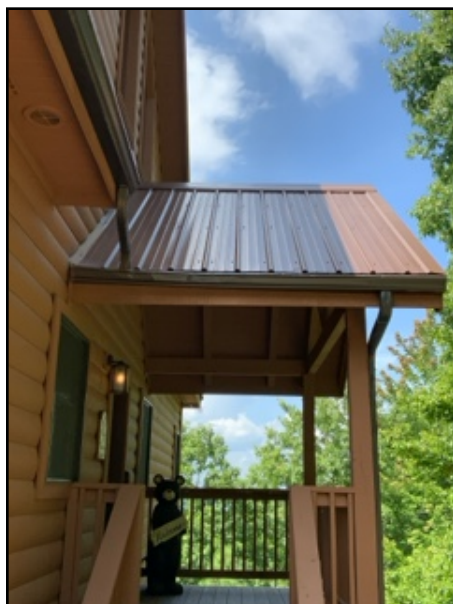
Figure 4-1

The mechanically damaged guttering at the rear porch entry should ideally be replaced.

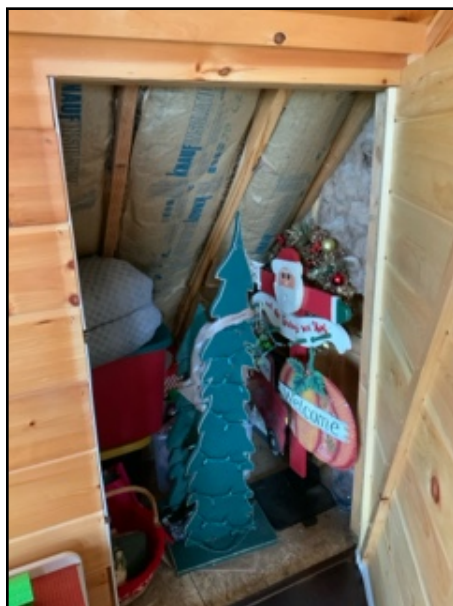
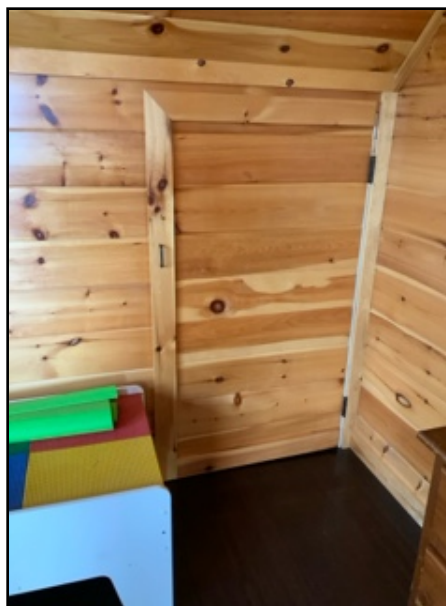
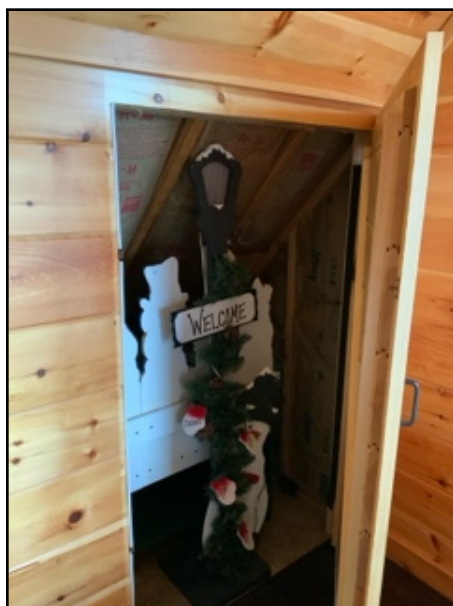
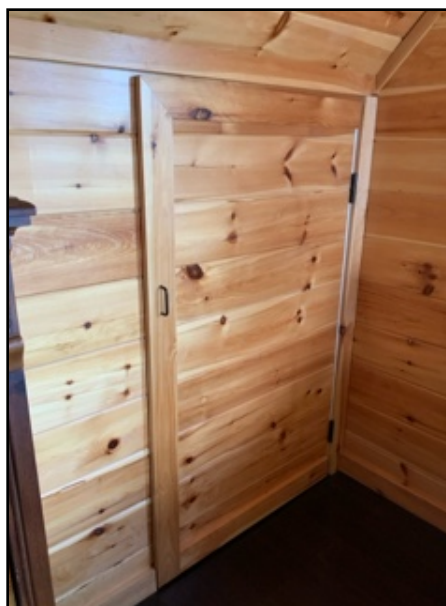
There is exposed batt insulation with the paper vapor barrier visible in the knee wall attics. Some jurisdictions allow the attic access door to be locked as a way to help to keep children from accessing the attic and to mitigate the fire hazard concern associated with this condition.

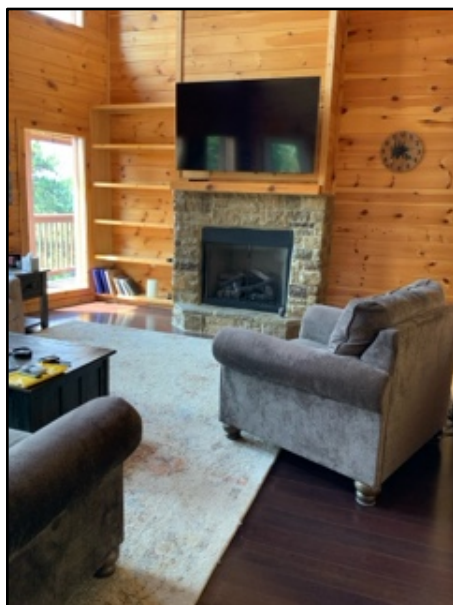
Figure 6-1

The installation of carbon monoxide detectors (in addition to smoke detectors) outside sleeping areas and on each living level are recommended for added safety when combustion appliances are used in a home, or, when an attached garage is adjacent to the living space.

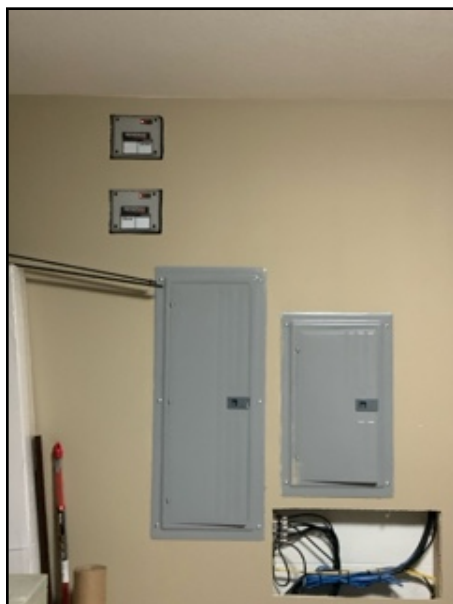
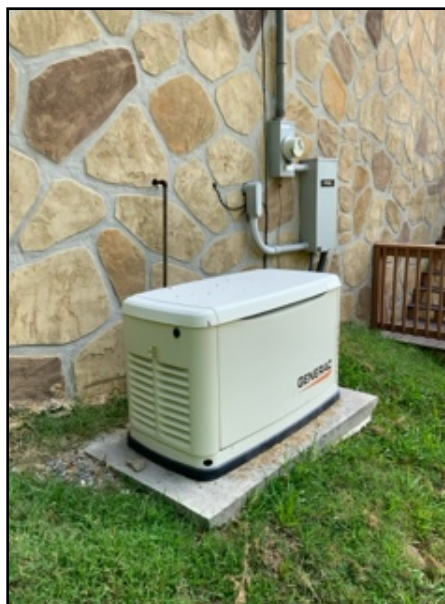
The Gnerac auxiliary power system was not inspected.

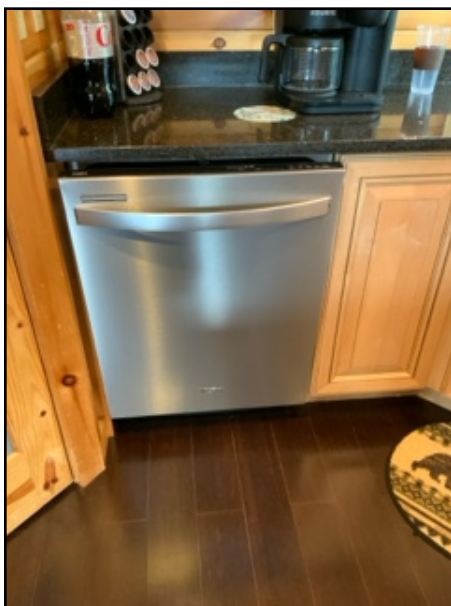
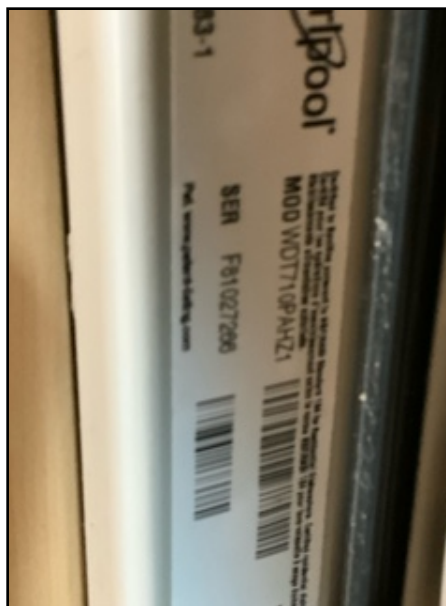
The dishwasher is an older unit based on normal life expectancy of dishwashers.

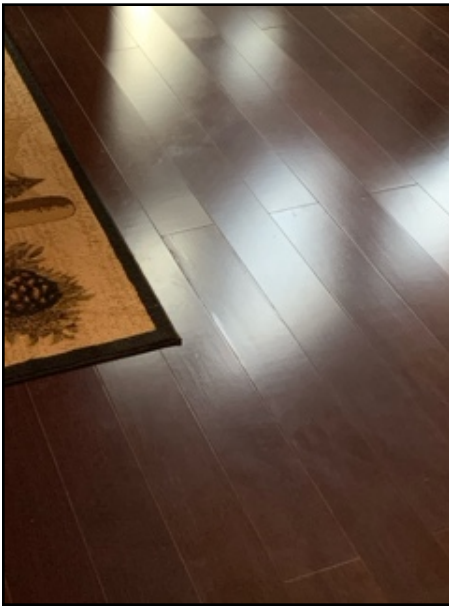
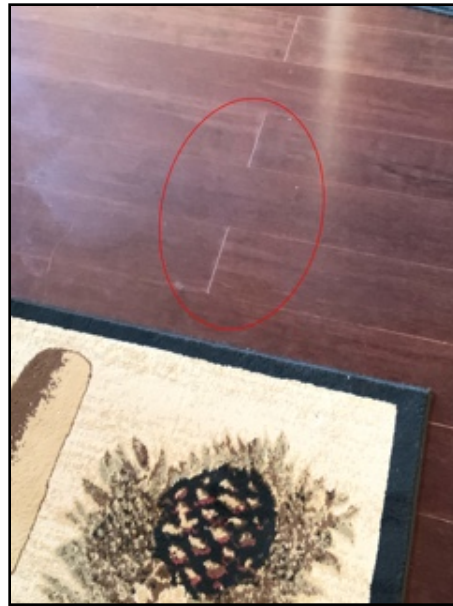
The wood floor has some minor cosmetic cracks.

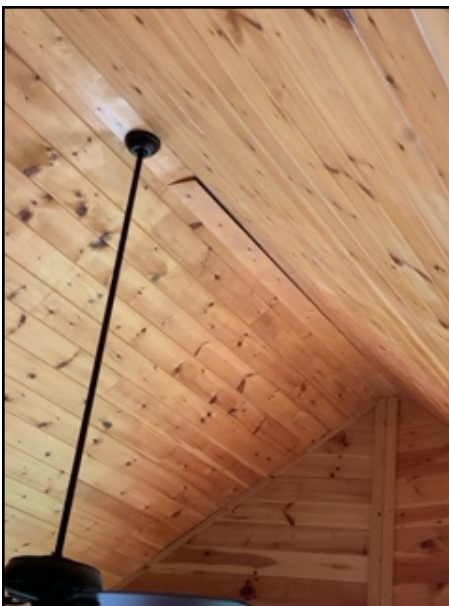
Figure 10-1

A loose trim board in the gable peak should be better secured for added safety.

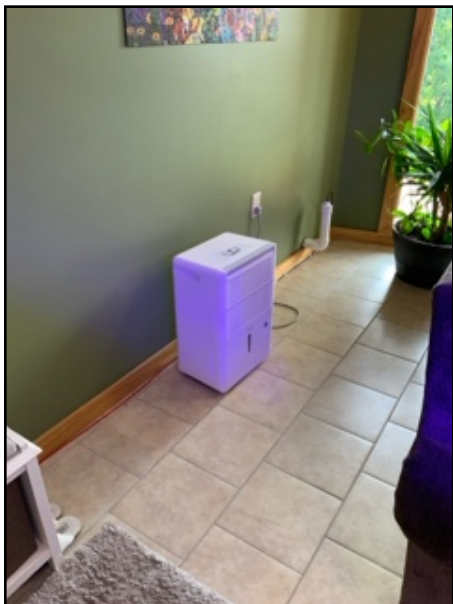
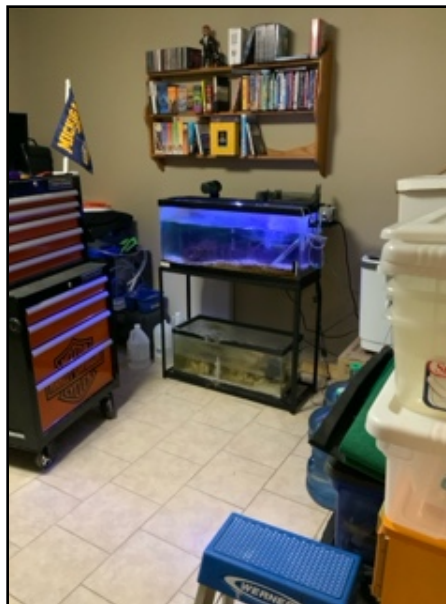
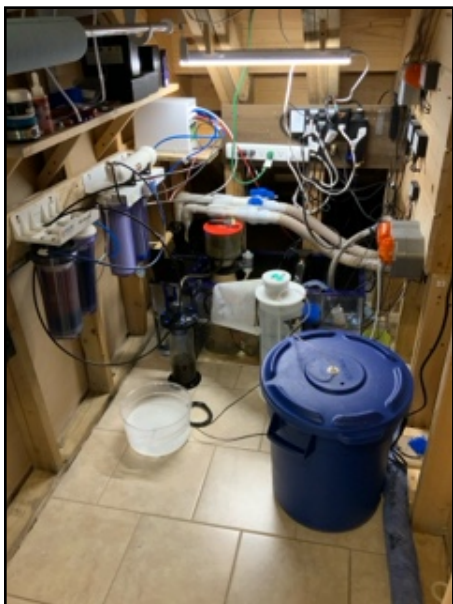
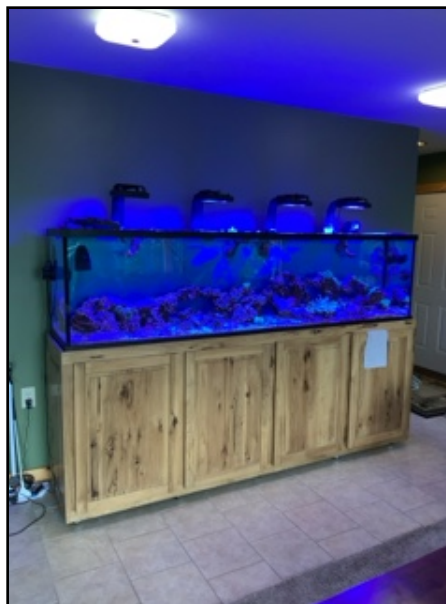
A dehumidifier is present in the lower level. The owner installed the dehumidifier due to the humidity created by the large aquarium and equipment installed in this area.
